UNITED STATES ENVIRONMENTAL PROTECTION AGENCY
REGION 5
77 WEST JACKSON BOULEVARD
CHICAGO, IL 60604-3590

Re: Notice of Violation
RCRA Compliance Evaluation Inspection
USVA Zablocki Medical Center, Milwaukee, Wisconsin
WI8 210 890 002

ZABLOCKI VETERANS AFFAIRS MEDICAL CENTER PHOTOGRAPH LOG

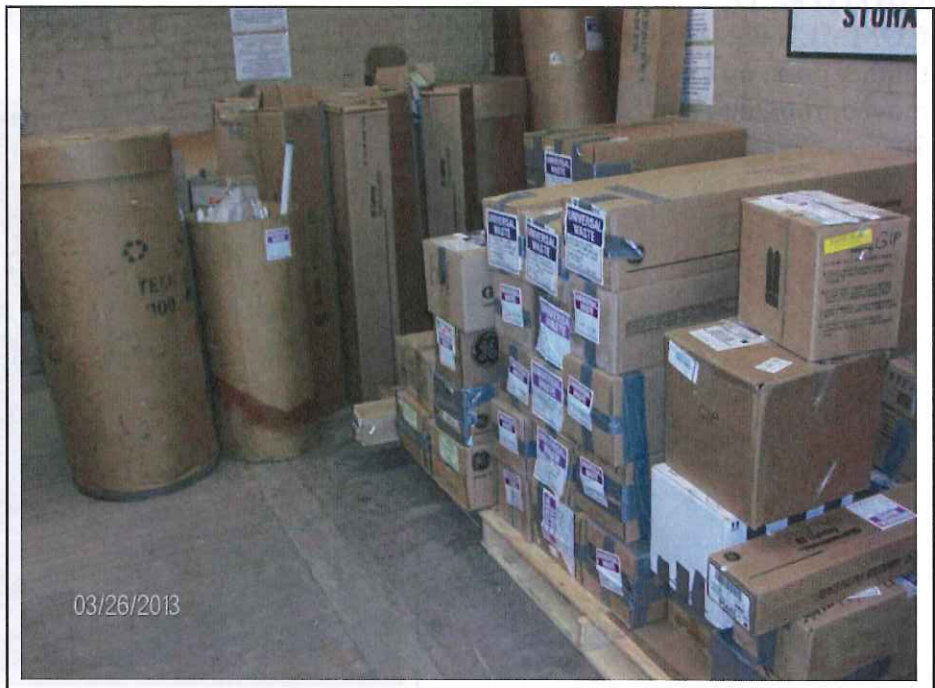
SITE LOCATION: Universal Waste Storage Area in Bldg. 20

COMMENTS: Overview of
containers of spent fluorescent lamps.

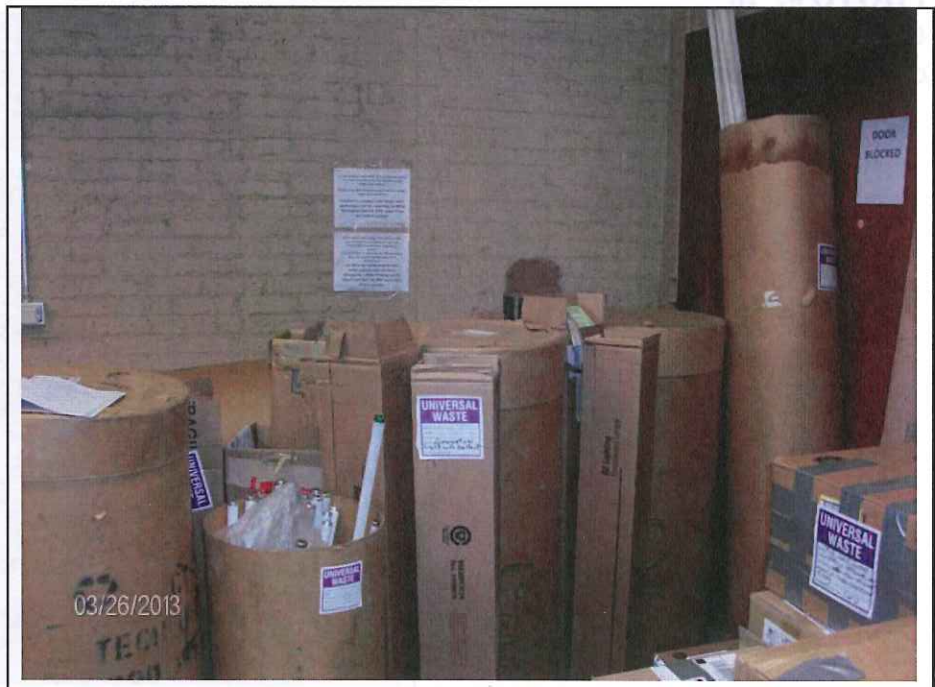
SITE LOCATION: Universal Waste Storage Area in Bldg. 20

During the inspection of the Universal Waste Storage Area in Building 20, the inspector observed approximately seven boxes of used fluorescent lamps which were not closed. At the time of the inspection, ZVAMC failed to comply with the small quantity handler containment requirements, as required by WAC § NR 673.13(4)(a) [40 CFR § 273.14(d)(1)].

Bldg. 20 is used as a warehouse and there was a designated area in the building for storage of spent fluorescent lamps managed as universal wastes. There were approximately 50 boxes of spent lamps in this area, and all the boxes appeared to be properly labeled (see Photo 19). I observed seven boxes that were not closed, including those that had no covers or had holes in them, and one box that did not have an ASD (see Photo 20).

COMMENTS: Closer view of
containers of spent fluorescent lamps
showing some of the containers that
were not closed. The rectangular box
in the middle of the photo with the
label facing out did not have an ASD.

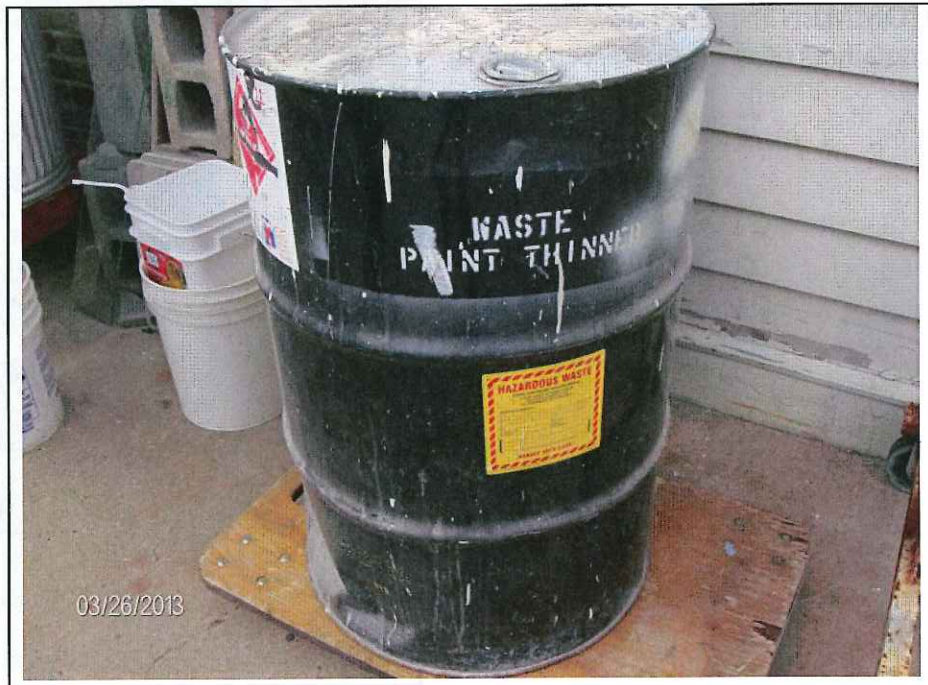
SITE LOCATION: Outside Paint Shop in Bldg. 97

I then inspected Bldg. 97 and observed a partially full drum of hazardous waste paint on the outside loading dock of the building (see Photo 17). Mr. Lilley reported the drum had been in Bldg. 70 and had been put on the loading dock until it could be picked up by the waste contractor. In the building in the Paint Shop was a drum for waste paints with a hazardous waste label and the words "Waste Solvent". Also in the shop was a paint booth (see Photo 18) that used filters to remove aerosols from the exhausted air. According to Mr. Lilley, the filters were

COMMENTS: View of waste paint thinner drum on loading dock that was moved from the Paint Shop in Bldg. 70.

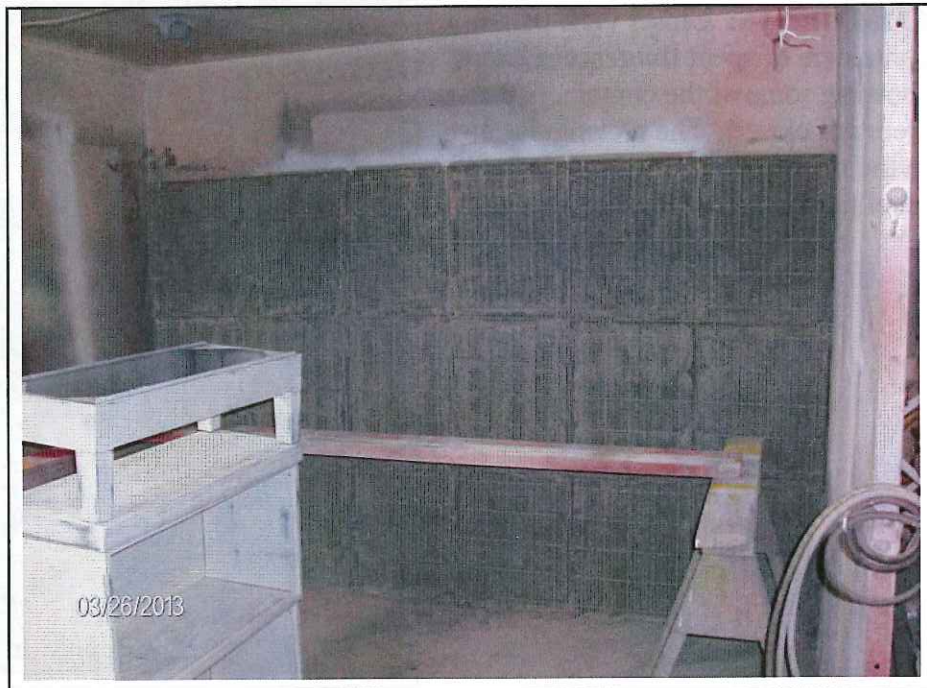
SITE LOCATION: Paint Shop in Bldg. 97

periodically changed, as needed, and the wastes were put in the trash. Mr. Stauder reported that he had performed a waste determination on the waste filters by checking the primary coatings used in the paint booth for hazardous constituents, but he had not had the wastes analyzed to verify they were not hazardous.

COMMENTS: Paint booth showing contaminated air filters.

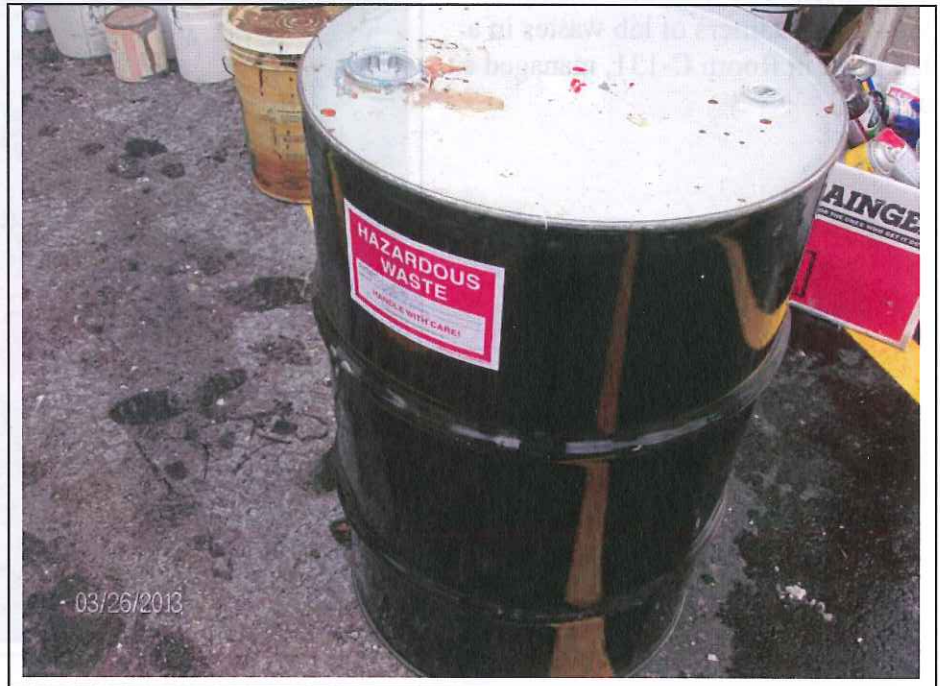
SITE LOCATION: Outside Stall 5 Next to Paint Shop in Bldg. 97

COMMENTS: Drum used to accumulate waste paints during preparation of the waste shipment by the waste contractor.

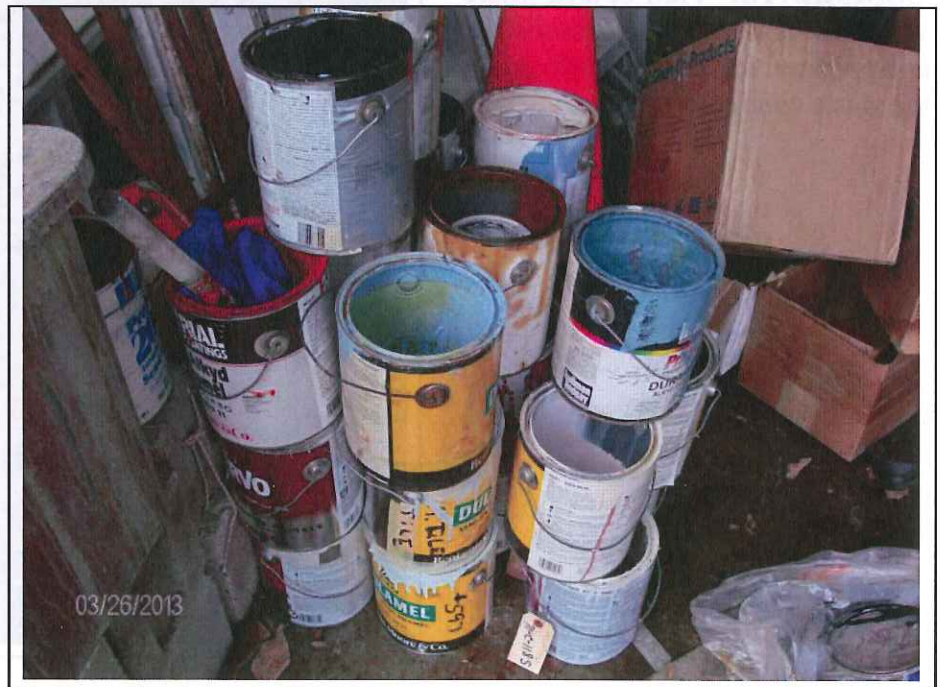
SITE LOCATION: Outside Stall 5 Next to Paint Shop in Bldg. 97

I first inspected the Paint Shop in the basement of Bldg. 70. The painter who was present in the shop reported that all the containers of paint had been recently removed when the room had been cleared out to replace the insulation, and only the good paint was put back in the room. I later went to inspect the Paint Shop in Bldg. 97 and observed the waste contractor processing paint wastes in front of Stall 5 next to Bldg. 97 (see Photo 14). The contractor had poured out cans of old paint, mostly from the Paint Shop in Bldg. 70, into a drum with a Hazardous Waste label and marked "Waste Paints" (see Photo 15). The empty cans were being air dried to solidify the remaining liquids (see Photo 16).

COMMENTS: Containers of paints that had been emptied into the drum in Photo #15 for off-site disposal. The containers were being air dried to solidify the remaining paints.

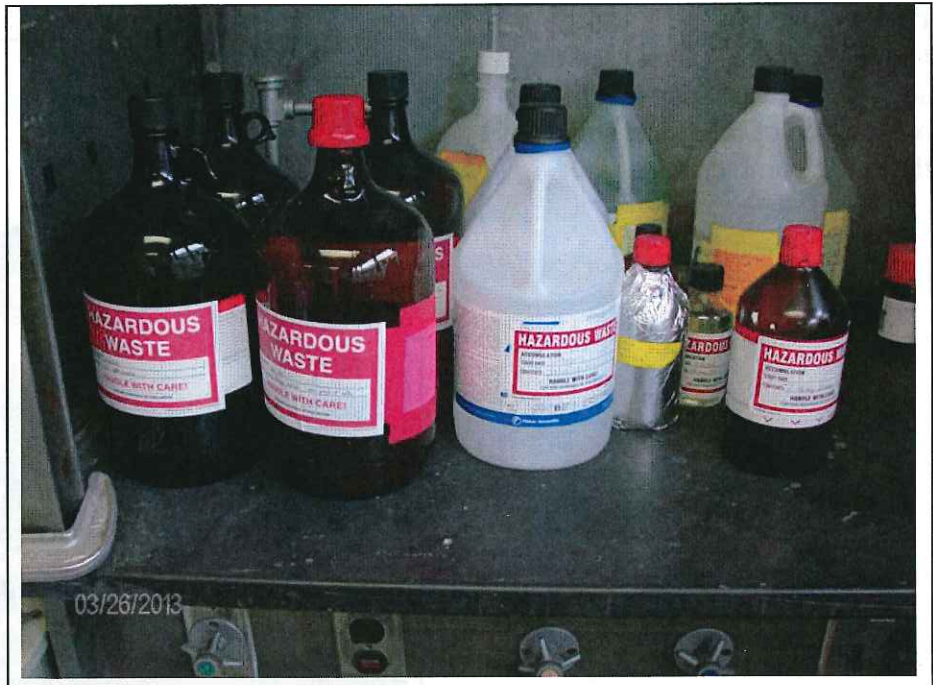
SITE LOCATION: Research Labs in Bldg. 70

COMMENTS: Another example view of containers of lab wastes in a lab hood in Room C-131, managed as a SAA.

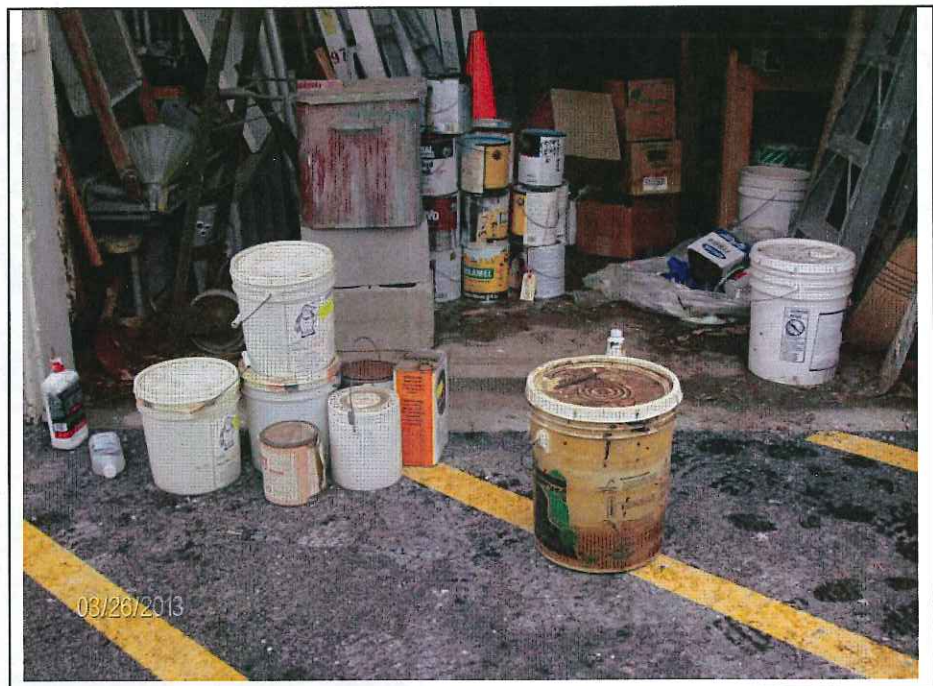
SITE LOCATION: Outside Stall 5 Next to the Bldg. 97 Paint Shop

COMMENTS: View of area where waste paints were being consolidated and prepared for shipment off-site by the waste contractor.

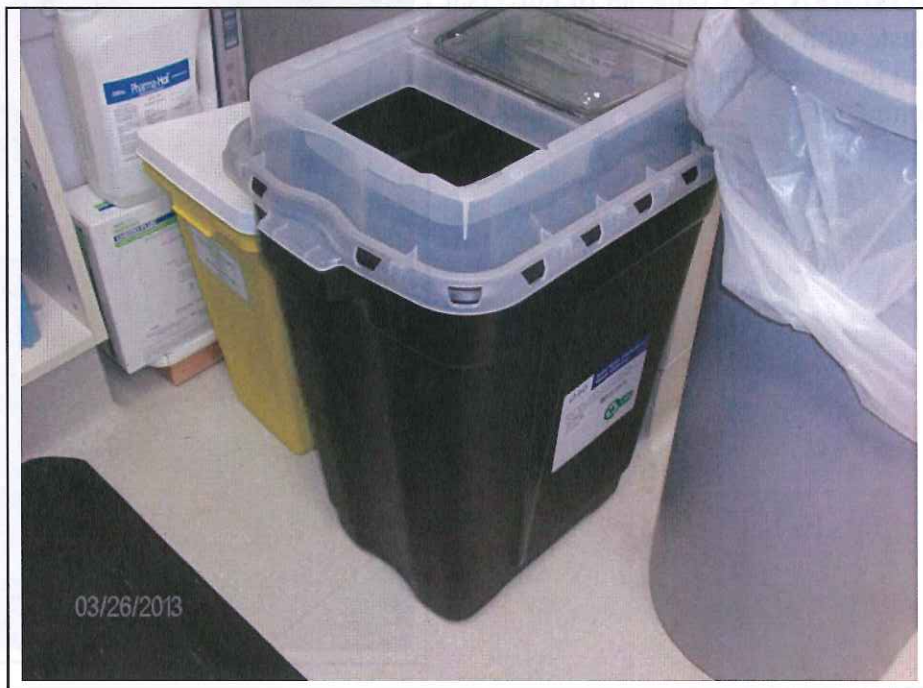
PHOTO #: 11

COMMENTS: View of container used to collect all RCRA hazardous waste chemotherapy drugs in their original containers and in plastic bags.

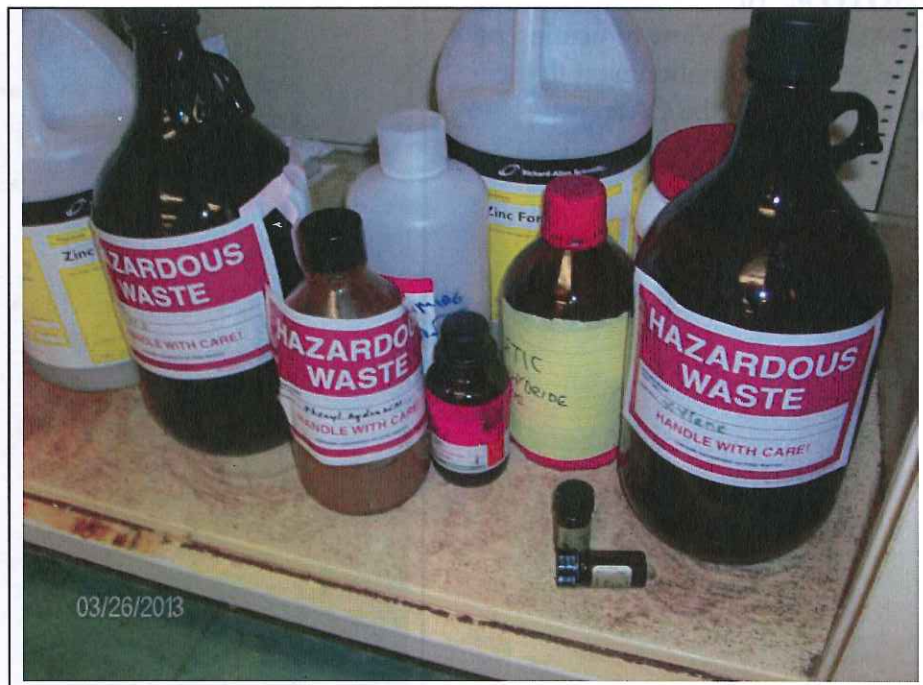
PHOTO #: 12

COMMENTS: Example view of containers of lab wastes in Room D-129 managed as a SAA.

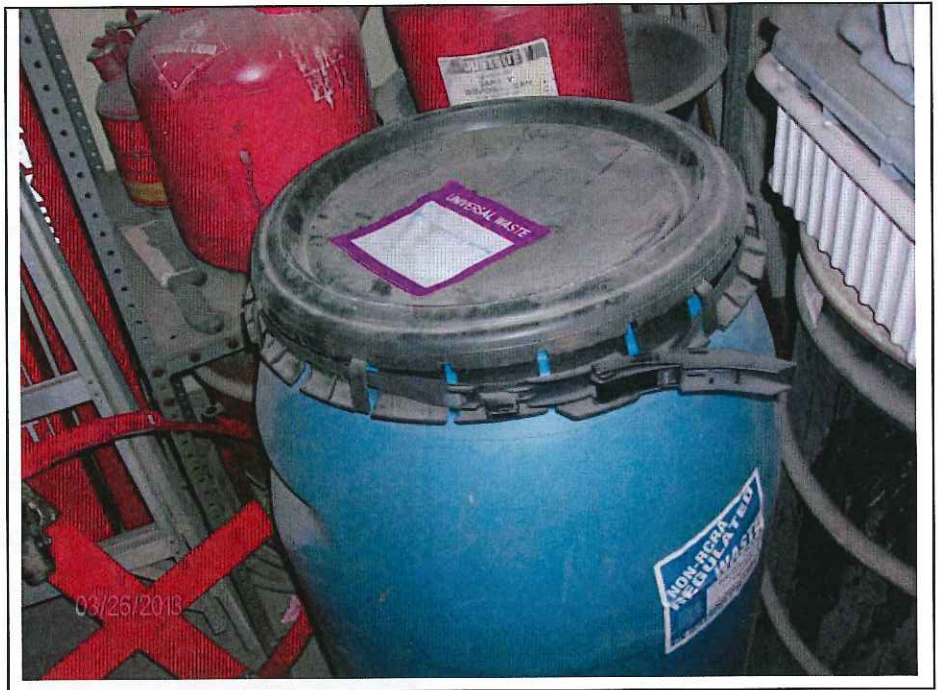
SITE LOCATION: Central Accumulation Area in Bldg. 70

During the inspection of the Central Accumulation Area in Building 70, the inspector observed a drum with a Universal Waste label and marked "Mercury Containing Waste" with an accumulation start date of "1/10/12". At the time of the inspection, ZVAMC failed to comply with the small quantity handler accumulation requirements, as required by WAC § NR 673.15(1) through (3) [40 CFR § 273.15(a) through (c)].

COMMENTS: Container of universal waste with an ASD of 1/10/12 that had just been emptied by the waste contractor.

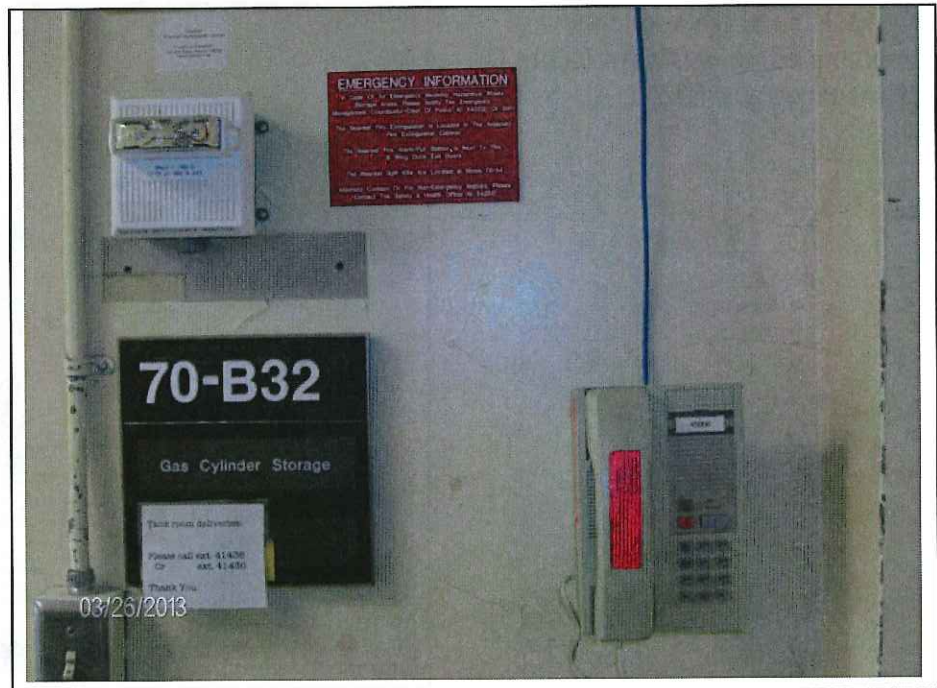
SITE LOCATION: Area Adjacent to Central Accumulation Area in Bldg. 70

COMMENTS: View of posting of emergency information next to the phone nearest to the CAA.

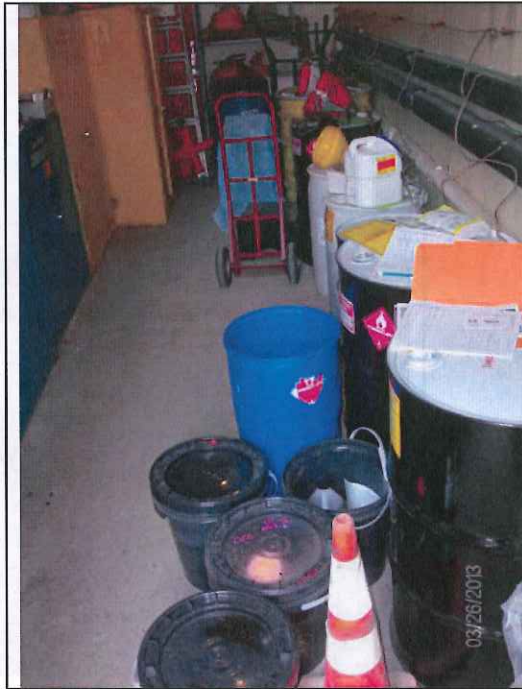
SITE LOCATION: Central Accumulation Area (CAA) in Bldg. 70

I next inspected the CAA which consisted of a room next to the loading dock (see Photo 7). At the time of the inspection, employees of Earth Smart Environmental Solutions were processing the wastes from the CAA to prepare them for shipment off-site in their truck. The inventory of hazardous waste containers in the CAA at the time of the inspection included the following: three drums marked "Waste Xylene"; one gallon container marked "Trace Metals Waste"; a 30-gallon container labeled "Waste Xylene"; a 30-gallon container marked "Waste Diaminobenzidine"; and a drum marked "Mercury Containing Waste".

COMMENTS: Overview of the CAA. A waste contractor was in the process of preparing and transporting hazardous waste in the CAA for off-site disposal.

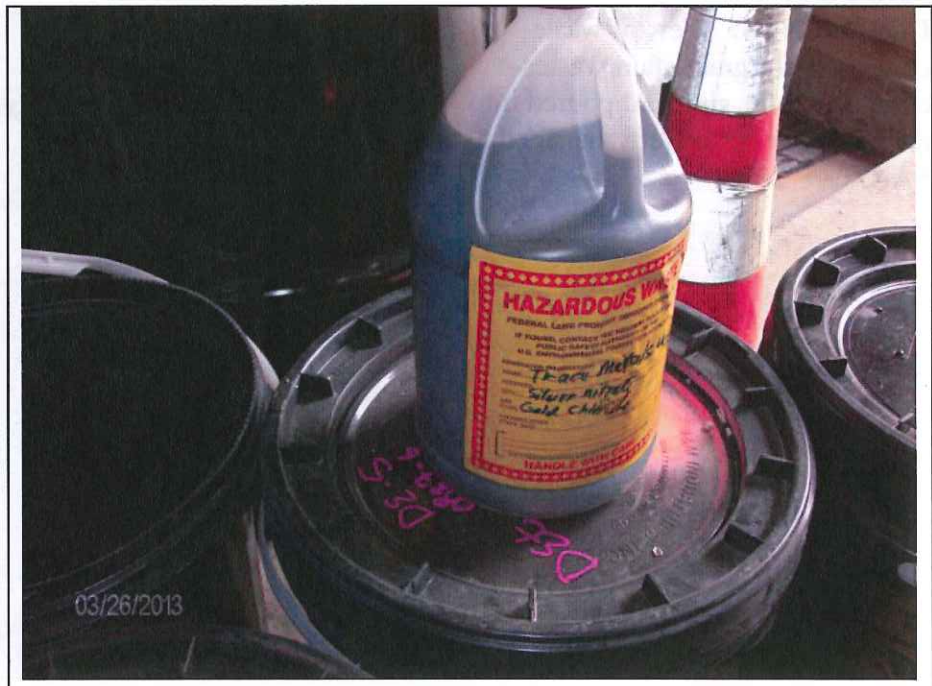
SITE LOCATION: Central Accumulation Area in Bldg. 70

During the inspection of the Central Accumulation Area in Building 70, the inspector observed a one-gallon container marked "Trace Metals Waste" which did not have an accumulation start date. At the time of the inspection, ZVAMC therefore, failed to comply with WAC § NR 662.192(1)(d)(1) [40 CFR § 262.34(d)(2)].

I inspected all of the containers in the CAA, and all were closed and had hazardous or universal waste labels with Accumulation Start Dates (ASDs), except for the one-gallon container marked "Trace Metals Waste" (see Photo 8) which did not have an ASD. Mr. Stauder contacted Ms. Cole who reported the container had been brought to the CAA the previous week. Also the drum with a Universal Waste label and marked "Mercury Containing Waste" had an ASD of 1/10/12 (see Photo 9). This drum was empty, and Mr. Stauder reported it had just been emptied by the waste contractor and appeared to have been stored more than a year.

COMMENTS: Container of hazardous waste without an accumulation start date (ASD).

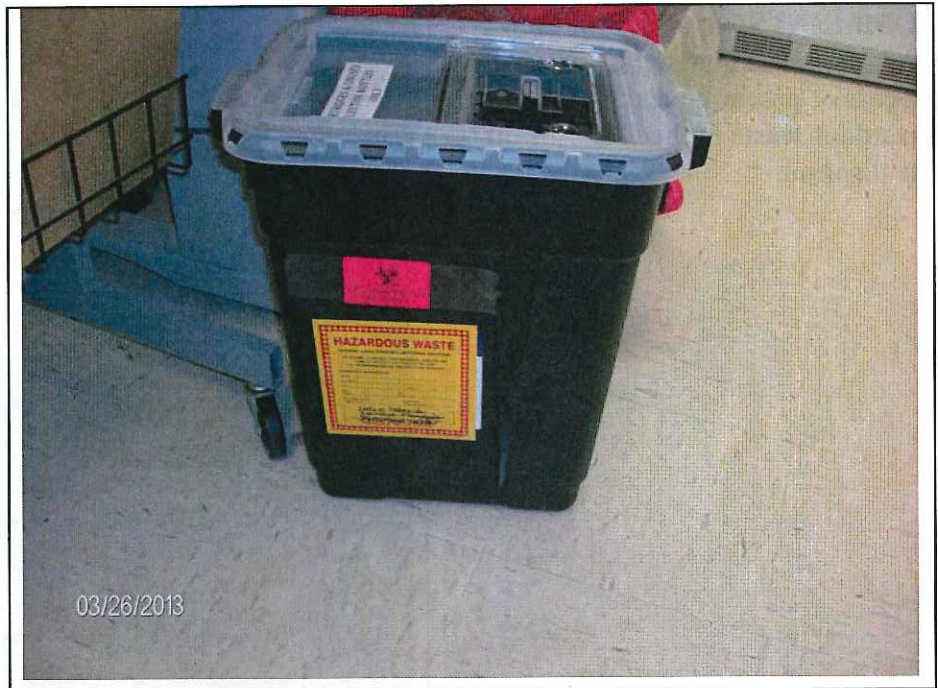
SITE LOCATION: Clinical Labs in Bldg. 111

COMMENTS: Container managed as a SAA for accumulating hazardous waste cartridges from other analytical instruments.

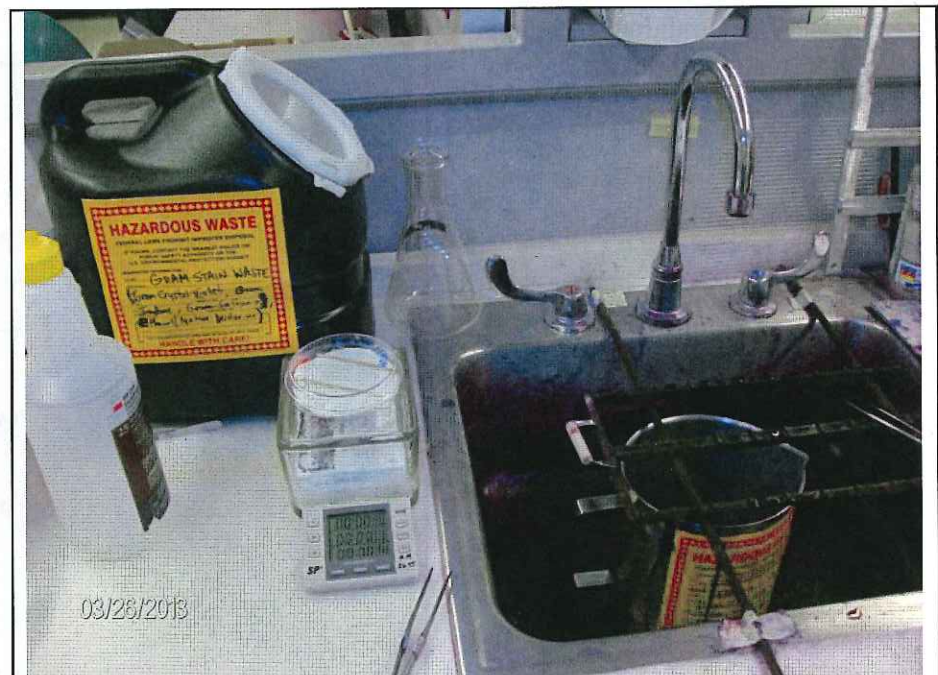
SITE LOCATION: Clinical Labs in Bldg. 111

COMMENTS: View of waste containers for gram stain wastes collected in the sink and poured into the container on the left, managed as a SAA.

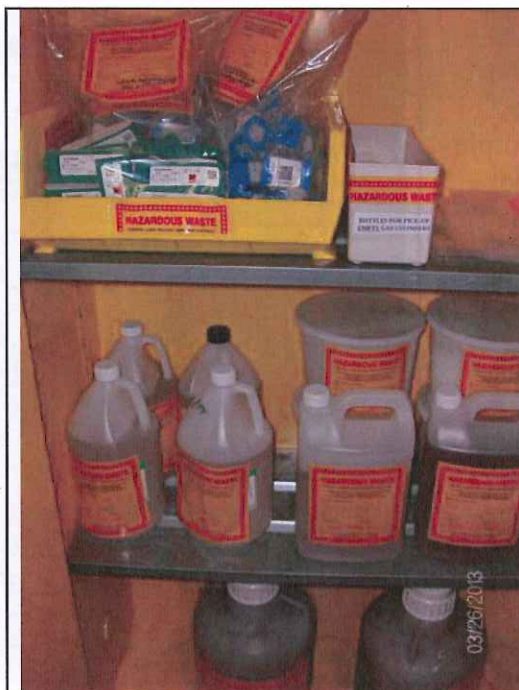
SITE LOCATION: Clinical Labs in Bldg. 111

COMMENTS: View of hazardous wastes generated from labs stored in a flammable locker in Room 2629.

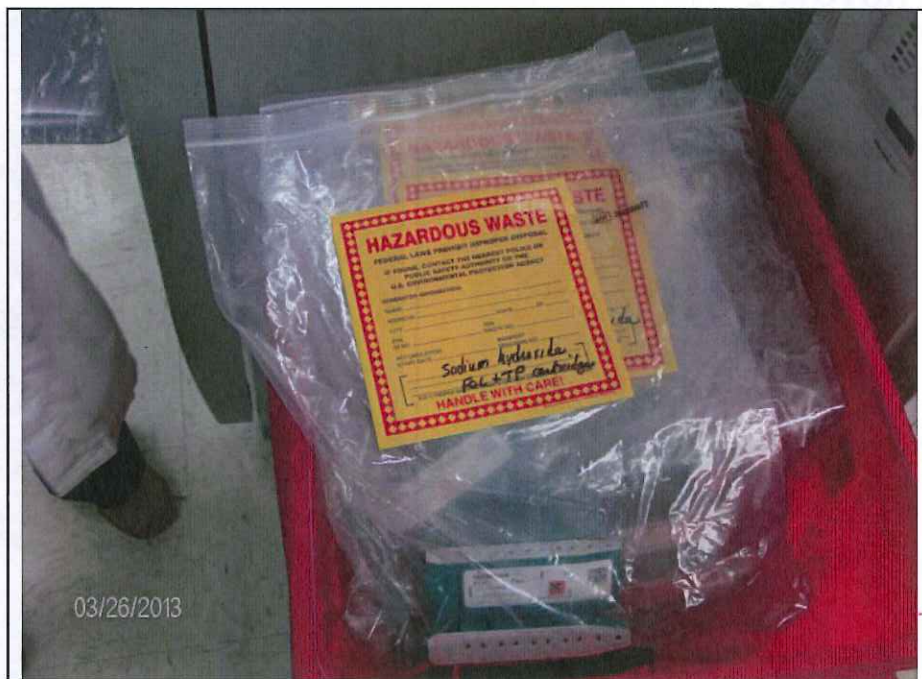
SITE LOCATION: Clinical Labs in Bldg. 111

COMMENTS: SAA for accumulating hazardous waste cartridges from the adjacent analytical instruments.

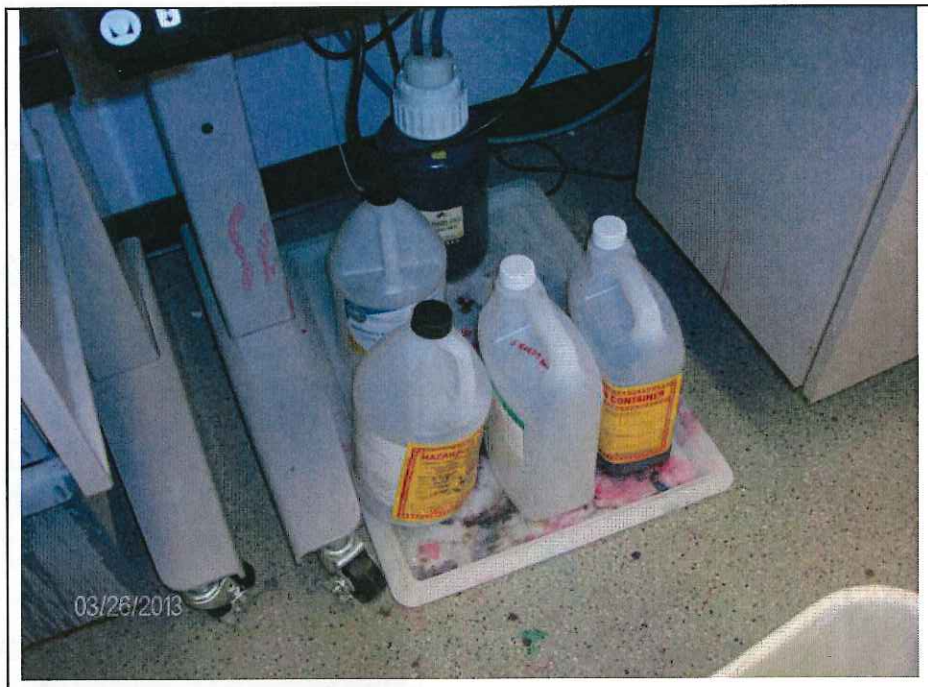
SITE LOCATION: Clinical Labs in Bldg. 111

During the inspection of the Clinical Laboratory (room number 2633) in Building 111, the inspector observed a hazardous waste SAA container that was not closed. At the time of the inspection, ZVAMC therefore failed to keep a SAA container closed, as required by WAC § NR 665.0173[40 CFR § 265.173(a)].

On 3/26/13, I first inspected the Clinical Labs in Bldg. 111, and Lisa Crivello was the hazardous waste contact for these labs. In Room 2633, I observed a container of waste combined stains with a hazardous waste label and a funnel in it that was not closed. The technician responsible for this waste quickly put the cover on the container (see Photo 1). I next visited Room 2629 which housed the solvent still, used to purify and reclaim waste alcohol and xylene (see Photo 2). Lyndsay Jones reported the still bottoms were put in containers and managed as hazardous waste, one of which was next to the solvent still and properly labeled and closed. Also in this room was a flammable locker used to store hazardous waste from the labs and managed as a SAA (see Photo 3).

COMMENTS: Containers of lab wastes in a Satellite Accumulation Area (SAA) in Room 2633. The container on the right with the purple fluid in it was first observed to be open with a funnel in it before the cover was replaced by the Lab Technician.

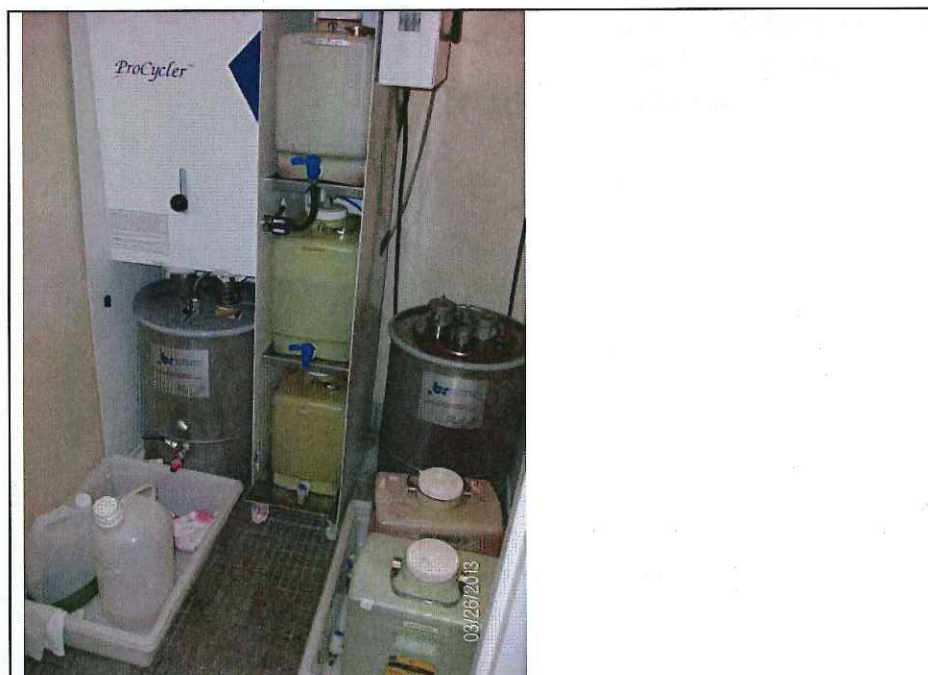
SITE LOCATION: Clinical Labs in Bldg. 111

COMMENTS: View of solvent reclamation still and containers of waste still bottoms and waste purified solvents and in Room 2629.
